Re: North Branch Hoosic River assessment at former site of Briggsville Dam

This letter discusses a geomorphic assessment of the North Branch Hoosic River in Briggsville, MA just upstream of the former site of the Briggsville Dam removed in 2010 (Figure 1). Ongoing erosion on the right bank of the river (looking downstream) (Figure 2) was initiated by record flooding during Tropical Storm Irene in 2011 (Web citation 1) that occurred shortly after completion of the dam removal. The erosion is of concern to a nearby condominium complex whose front lawn, on a slightly lower surface, becomes smaller with each passing flood as the erosion progresses. The assessment was undertaken to determine the possible causes of erosion and to identify bank stabilization solutions that can simultaneously enhance habitat along this section of the river. The assessment consisted of a site visit on April 8, 2024 and a review of online topographic maps, aerial photographs, and past studies as discussed in further detail below.

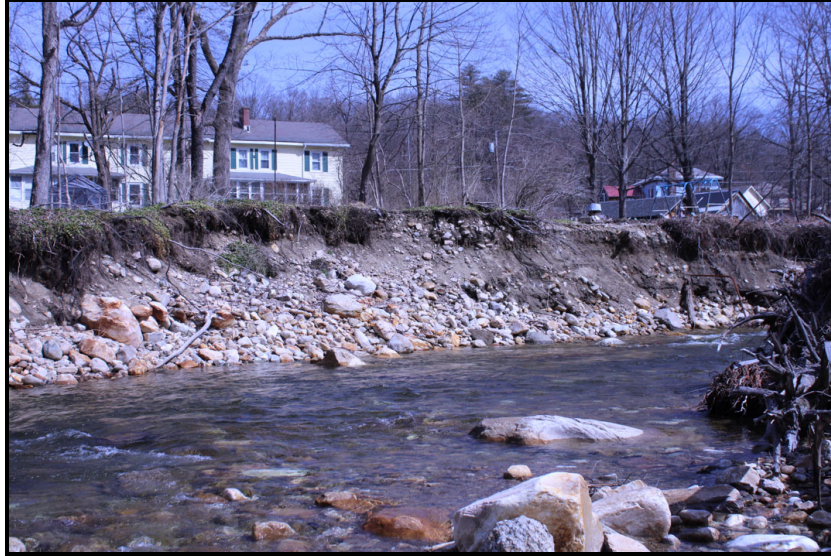
Figure 2. Bank erosion on right bank of North Branch Hoosic River just upstream of former Briggsville Dam. Note condominium complex (yellow building) in background.

channel present on the left bank along Route 8. Formation of the mid-channel bar also eroded away the constructed floodplain and initiated the ongoing bank erosion (Figures 2 and 7).

Long before the dam removal, the North Branch Hoosic River was artificially manipulated in other ways that may be contributing to the erosion of the right bank upstream of the former dam site (Figures 2 and 7). Although the valley bottom is narrow, the presence of a straight channel flowing directly against the higher valley side slopes near the former Briggsville Dam is suggestive of artificial channel straightening. Straightened channels result in energized flows (due to shortening of the channel) and artificially sharp bends (where two separately channelized segments join) such as at the location of (and likely related to) the large mass failure downstream of the former dam (Figures 1 and 6). The channel straightening was almost certainly

Three bank stabilization options for the eroding right bank (Figure 2) are considered here: 1) construction of boulder deflectors along the eroding bank; 2) construction of boulder weirs across the channel; and 3) removal of the earthen berm and artificial fill. The pros and cons of each option are considered based on an analysis of six factors related to each stabilization technique: 1) appropriateness for the site; 2) durability and effectiveness; 3) consistency with natural processes; 4) temporary construction impacts; 5) habitat enhancement; and 6) potential impacts elsewhere (i.e., across channel and downstream) (Table 1). The chosen option will need to undergo a more thorough design phase to estimate costs, determine permitting requirements, and support grant applications for implementation funds. Owners of the condominium units and other stakeholders should be engaged throughout the decision-making process to gauge their response to the temporary and long-term impacts of each stabilization option.

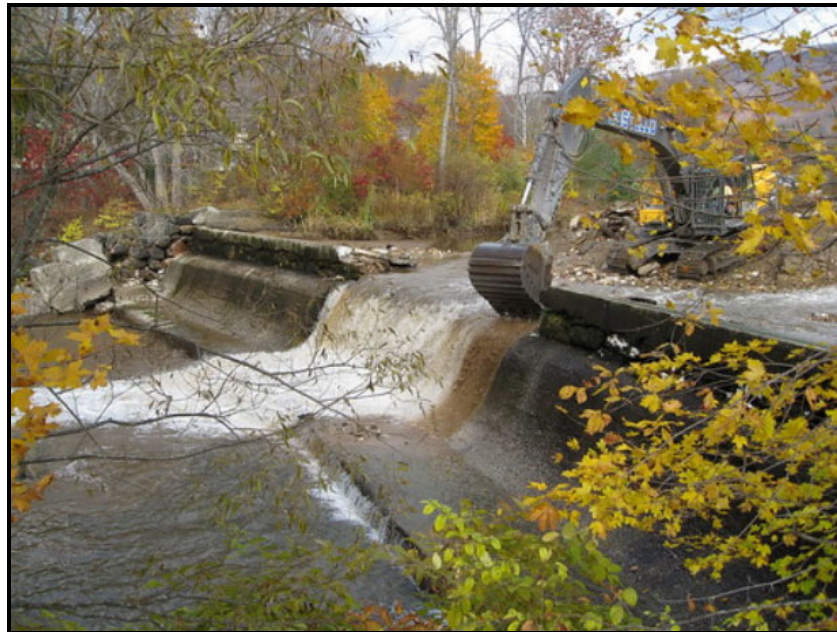
The 15-foot-high 145-foot-long Briggsville Dam was removed to open up 30 miles of high quality habitat to benefit Eastern brook trout and other coldwater species at a time when the dam owner was facing expensive repairs to the aging structure (Figure 3; Web citation 2). An earthen berm on the right bank downstream of the dam was not removed as part of the dam removal (Figure 4) and separates the river from a now forested swale that may have originally served as a tailrace downstream of the dam. As part of the dam removal, sediment that had accumulated in the impoundment to the top of the dam was partially removed to form a graded channel and an inset floodplain such that no steep drop existed at the dam following the removal (Figure 5).

Figure 3. Removal of the Briggsville Dam in 2010. (From Web citation 2)

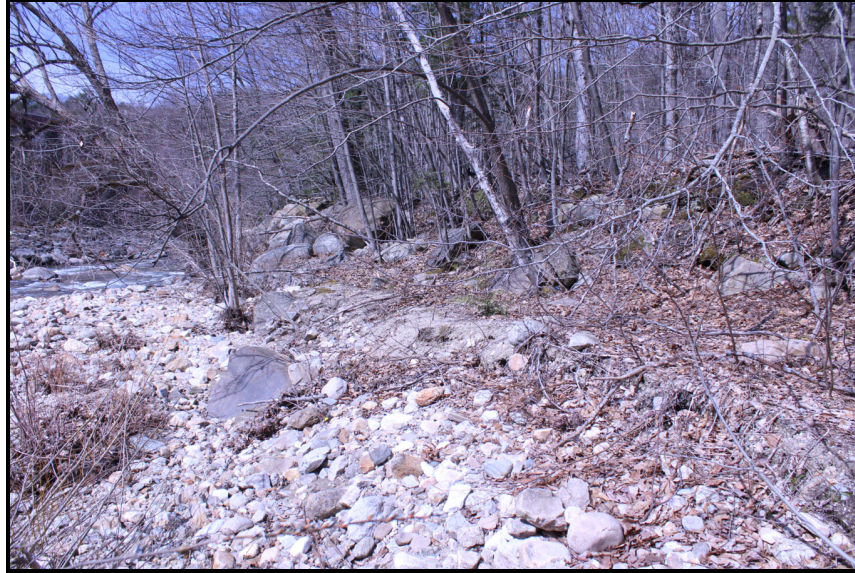
Figure 4. Earthen berm (faced with large boulders in the trees) downstream of the former dam.

From a technical perspective, the most significant drawback to removing the earthen berm is the removal of the large mature trees presently growing on the berm (Figure 4). Regrowth of trees would take many years, but potentially shortened with the replanting of larger trees immediately after berm removal. Perhaps a more significant issue with berm and fill removal is public resistance to the dramatic change in the surroundings. Currently, the condominiums are only slightly higher than the top of the artificial fill surface that is eroding along the river's edge. After fill removal, the restored floodplain would be several feet lower. The floodplain could still be used as a lawn and playground, as is the case today, with steps built to access the lower surface. The restored floodplain would be inundated more frequently than the currently higher surface, but would only be inaccessible a few days each year during larger flow events.

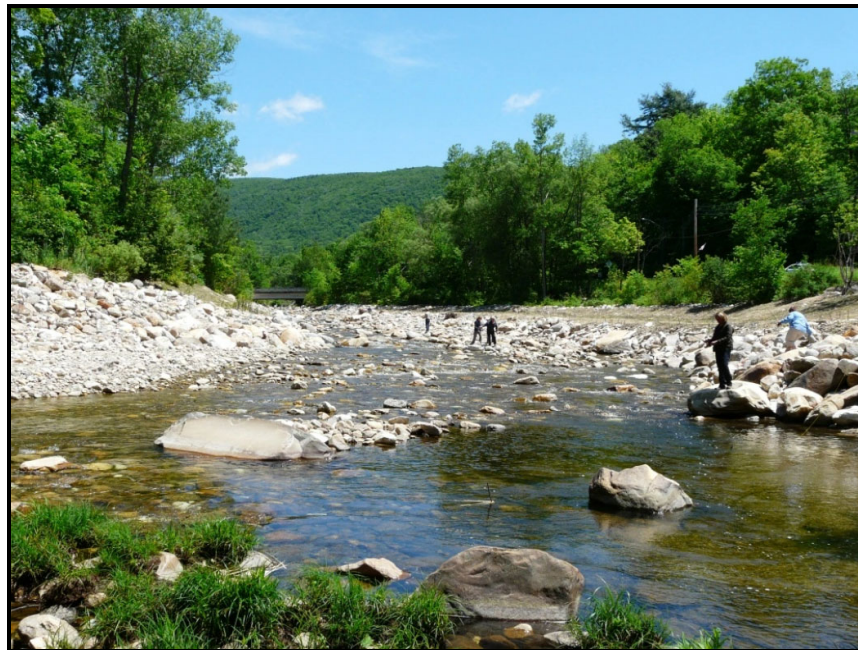
Figure 5. Looking upstream through the old dam site at the excavated channel and inset floodplain constructed upstream of the former dam prior to Tropical Storm Irene. (From Web citation 3)

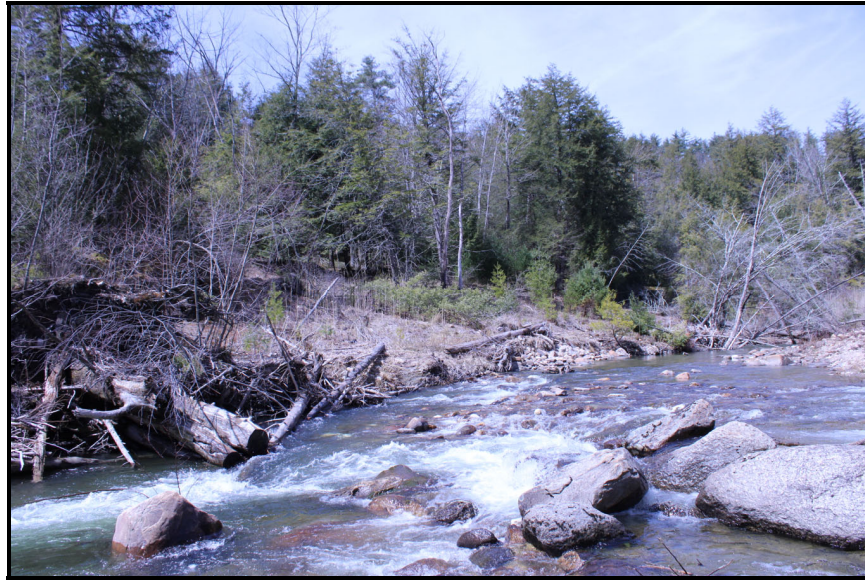
Tropical Storm Irene caused record flooding on the North Branch Hoosic River in August 2011 and led to severe bank erosion that damaged Route 8 just 0.2 mi upstream of the former dam site (Figure 1; Web citation 3). In addition, a large mass failure occurred relatively recently at the sharp bend in the river downstream of the dam and is assumed to have occurred during Tropical Storm Irene (Figure 6). Glacial clay present along the stream bottom suggests the river may have been temporarily dammed by the landslide. The flooding also largely infilled with coarse sediment the excavated channel upstream of the removed dam, forming a large mid-channel gravel bar that has diverted the majority of flow towards the right bank with a secondary side

Figure 6. Portion of mass wasting area at sharp bend downstream of former dam (see Figure 1).

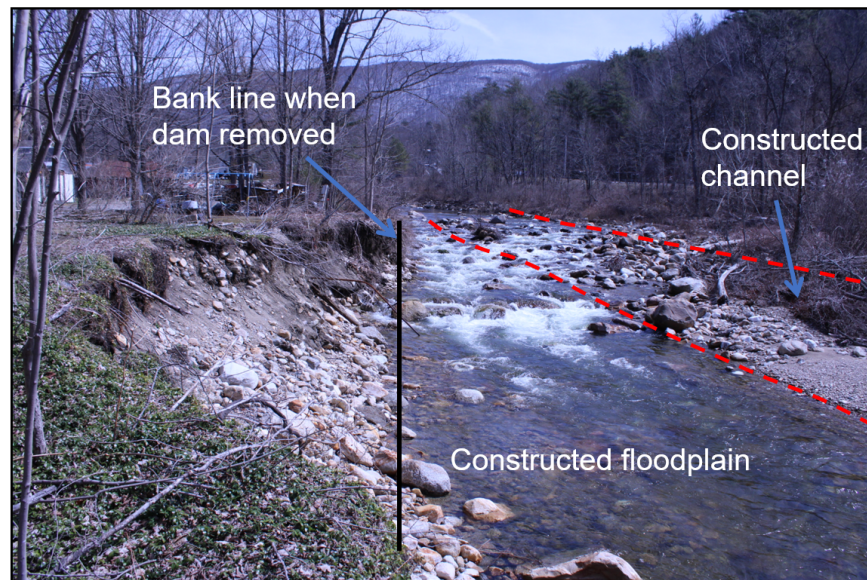
Figure 7. Deposition in constructed channel diverted flow towards the right bank and initiated ongoing bank erosion. View looking upstream.

In conclusion, channel constraints that remain (i.e., the earthen berm) following the 2010 dam removal have caused significant channel deposition upstream of the former dam and the initiation of erosion along the right bank into artificial fill (Figure 7). While stabilization of the current bank is possible, construction would be difficult given the loose unconsolidated fill and channel constraints would remain in place such that erosive forces and flood peaks downstream would not be reduced. Removal of the earthen berm (Figure 4) and artificial fill (Figure 2) would greatly transform the site in a way that might be initially unpopular among local residents, but represents the most sustainable way of reducing the erosive forces at the site while also improving aquatic habitat. Since this approach is also the most consistent with natural processes and the most likely to reduce flood hazards to downstream infrastructure, grant funds for implementation could be more readily secured from environmental or hazard mitigation programs. If you have any questions regarding the results of this geomorphic assessment, feel free to contact me at any time at 207-491-9541 or jfield@field-geology.com.

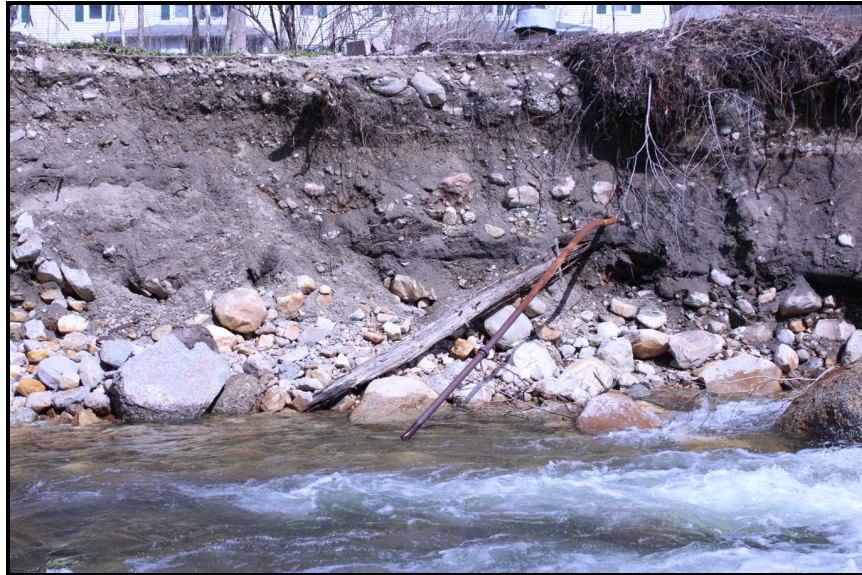
accompanied with artificial filling of the floodplain when the mill buildings and associated infrastructure were built, thus constricting more flow to the channel before floods are able to spread across the full width of the valley bottom. The eroding bank upstream of the former dam is itself composed of artificial fill as evidenced by the poorly sorted unstratified mix of cobbles and fine sediment with pipes and other historic artifacts eroding out of the bank (Figure 8). The fill may have been placed in portions of what was once a larger impoundment with the bank erosion into that fill exposing remnants of an older dam that may have contained that larger impoundment (Figure 9). Relatively uncompacted artificial fill is generally more susceptible to erosion than more compacted native soils.

Figure 8. The eroding right bank upstream of the former dam is composed of artificial fill.

Lateral outflanking of deflectors is also a significant risk at the Briggsville site given that the eroding bank along which the deflectors will be built is composed of uncompacted artificial fill (Figure 8). Scour is most severe where softer materials are in contact with harder materials such as boulders. While this problem could be mitigated by baffling the flow's energy with logs and brush anchored over the contact between the boulders and loose fill, the excavation into the uncompacted fill that will be required along much of the bank to both anchor these protective logs and to set the footer boulders of the deflectors could cause significant collapse of the loose fill and compromise the integrity of the structures from the outset.

The eroding right bank upstream of the former dam, as described above, is composed of artificial fill (Figure 8). Investing considerable funds to stabilize the eroding bank may not be advisable given that the uncompacted nature of the fill increases the risk of outflanking. Restoring the natural floodplain that existed prior to dam construction through removal of the earthen berm (Figure 4), artificial fill (Figures 2, 7, and 8), and remnant of old dam (Figure 9) provides a more sustainable approach for reducing erosive forces in the immediate area as well as further downstream (Appendix 1). The berm and fill are currently artificially constraining floods such that they impart a greater erosive force on the channel margins and more quickly convey flows downstream, potentially increasing the risk of large mass failures as has occurred in the past (Figures 1 and 6). By removing these constraining features, floodplain flow could be restored on the right bank, reducing erosive forces on the left bank along Route 8 and further downstream where considerable infrastructure and high unstable banks are present. Restoring the floodplain would also be beneficial to aquatic organisms by reducing flow velocities in the channel and providing side-channel habitat on the restored floodplain.

Removal of the artificial fill would address the bank erosion by greatly reducing the height of the bank; the current bank height did not exist prior to dam construction and placement of the fill. The final height of the floodplain and remaining bank will have to be determined in a later project design phase, but erosive forces on the remaining low bank will be greatly reduced by allowing flows to access the restored floodplain. While erosion of the low bank is still possible, allowing the river to migrate across the floodplain would provide greater resiliency during large flood events and minimize erosive forces and flood peaks downstream (Table 1). Given the presence of the condominiums on the higher surface (Figure 2), the back side of the lowered floodplain surface would need to be stabilized to ensure significant channel migration does not initiate erosion of the higher surface. The use of a log crib wall filled with large rock could be used for stabilization to provide both habitat and a greater peace of mind to residents potentially concerned about the risk of erosion closer to the condominiums (Appendix 1). However, erosion along the backside of the floodplain is unlikely to ever be a severe threat for at least three reasons. First, the slope rising to the level of the condominiums is composed of native less erosive materials compared to the currently eroding bank of artificial fill (Figure 2). Second, the erosive forces of flow on the floodplain will not be as strong as those currently present in the confined channel. Finally, removal of the earthen berm downstream (Figure 4) will reduce or eliminate the backwatering of flood flows that led to the deposition of the mid-channel bar and subsequent flow diversion into the now eroding right bank (Figure 7). If the berm is removed, sediment will more readily pass through the area, the size of the mid-channel bar will be reduced over time, and redirection of flow towards the right bank will be less likely.

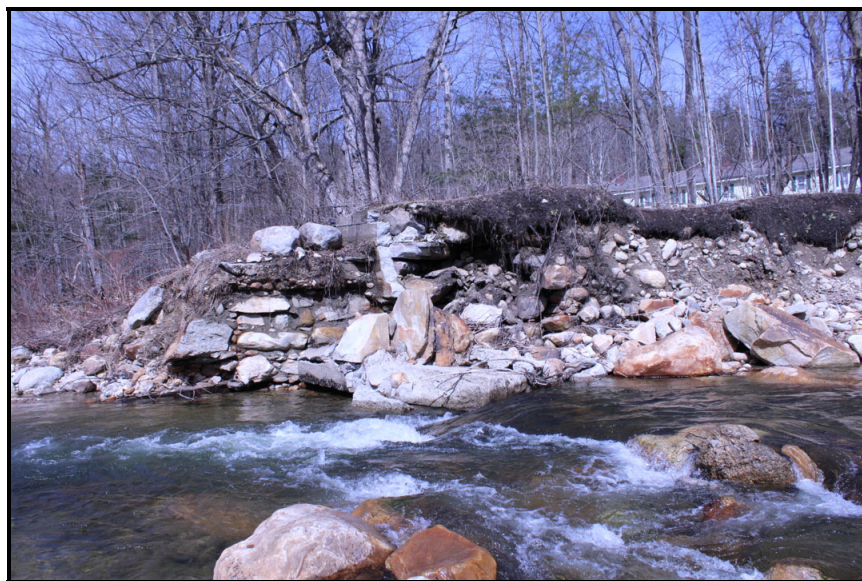
Figure 9. A short portion of an older dam has been exposed by erosion of the right bank.

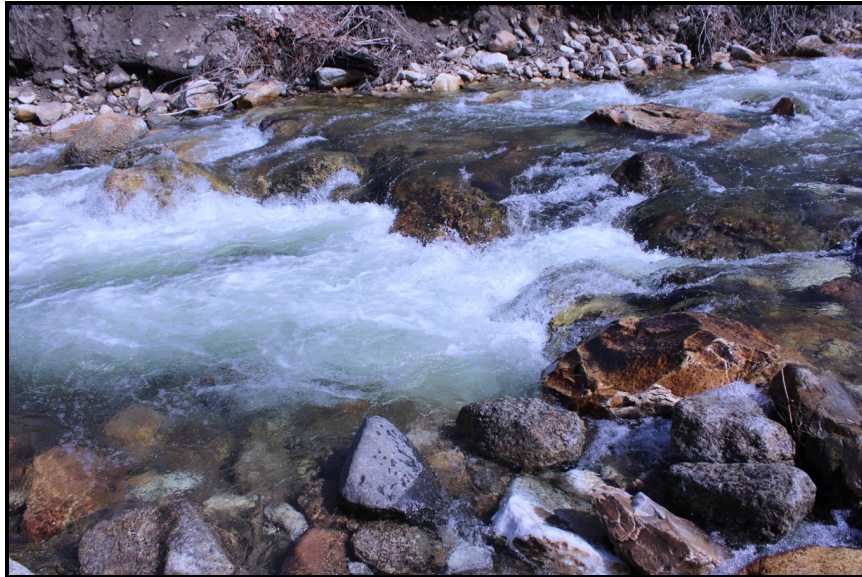
The section of channel adjacent to the eroding bank appears steeper than nearby sections upstream and downstream. This steep section may represent a headcut that may slowly migrate upstream as the channel bed adjusts to the lower base level resulting from the removal of the former 15-foot high Briggsville Dam. Lowering of the channel bed may further destabilize the eroding bank and extend the erosion further upstream. Currently, the channel bed has naturally armored itself with large rock that, in one location, forms a boulder weir across the main channel (Figure 10), essentially freezing the headcut in place as long as the boulders remain immobile during future floods. Alternatively, continued bank erosion could outflank the boulders in the channel and allow the headcut to migrate further upstream.

Figure 10. A natural V-shaped boulder weir has developed along the eroding bank and is currently preventing the further advancement of a headcut that could continue to undermine and destabilize the eroding bank.

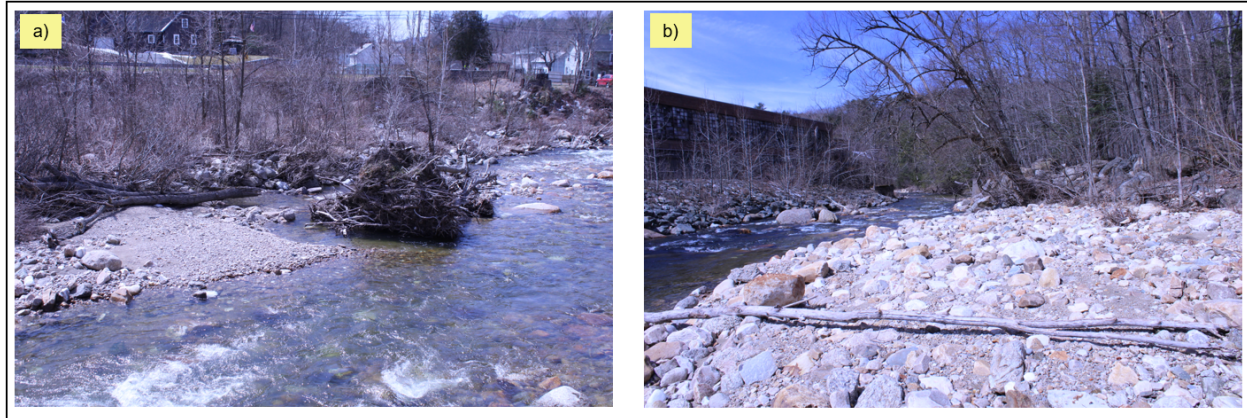
Deflectors at the Briggsville site are likely to induce sediment deposition effectively at the toe of the eroding bank given the considerable amount of sediment deposited around logs and other obstructions in the area (Figure 11). However, boulder deflectors are prone to damage from undermining of the footer boulders by bed scour or lateral outflanking around the back end of the structures where they tie into the bank (Table 1). Both problems are valid concerns at the Briggsville site. The steep channel bed upstream of the former dam is currently maintained by large boulders armoring the channel bed (Figure 10) but if that armor layer is mobilized, then bed scour will occur rapidly as the bed slope adjusts to the lower river level resulting from the dam removal. While the footer boulders can protect against minor bed scour created by the structure itself, footer boulders cannot protect against the significant bed lowering related to the dam removal.

Figure 11. The river is sensitive to deposition near the former dam site as evidenced by a) sand and gravel accumulating around a large root wad along the margins of the mid-channel bar and b) a large cobble bar formed downstream of the remnant dam protruding from the right bank (see Figure 9).
