Re: North Branch Hoosic River assessment at former site of Briggsville Dam

This letter discusses a geomorphic assessment of the North Branch Hoosic River in Briggsville, MA just upstream of the former site of the Briggsville Dam removed in 2010 (Figure 1). Ongoing erosion on the right bank of the river (looking downstream) (Figure 2) was initiated by record flooding during Tropical Storm Irene in 2011 (Web citation 1) that occurred shortly after completion of the dam removal. The erosion is of concern to a nearby condominium complex whose front lawn, on a slightly lower surface, becomes smaller with each passing flood as the erosion progresses. The assessment was undertaken to determine the possible causes of erosion and to identify bank stabilization solutions that can simultaneously enhance habitat along this section of the river. The assessment consisted of a site visit on April 8, 2024 and a review of online topographic maps, aerial photographs, and past studies as discussed in further detail below.

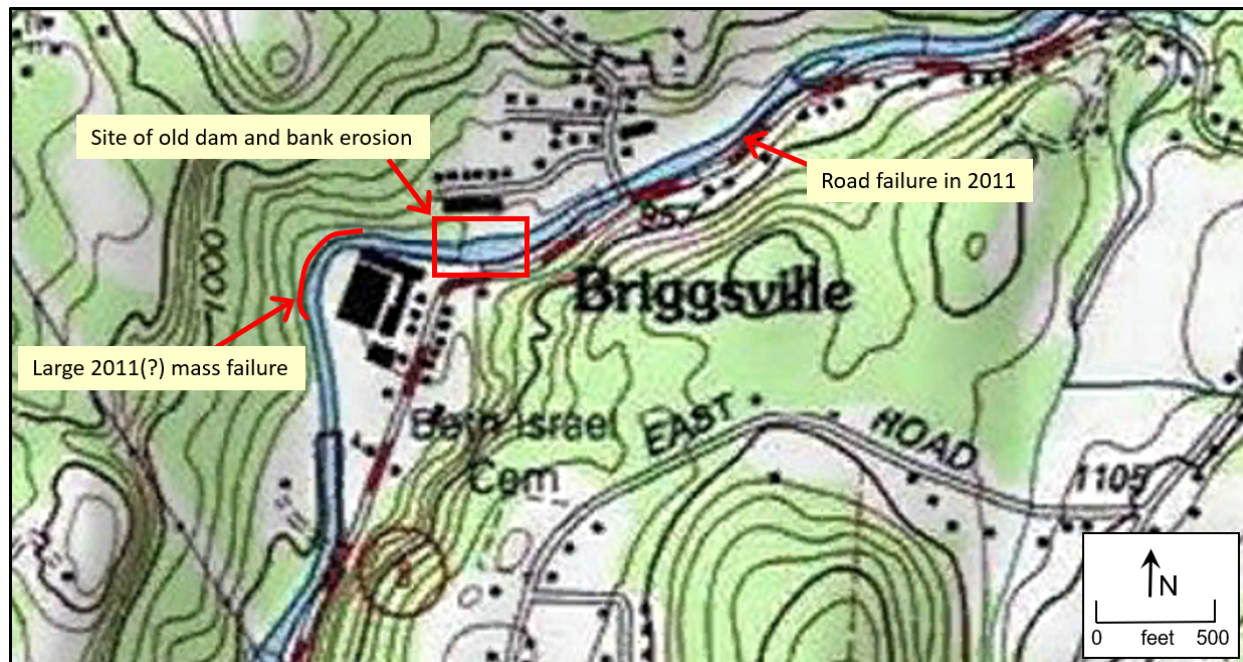
Figure 1. Location of the former Briggsville Dam and ongoing erosion as well as other sites mentioned in text.

Tropical Storm Irene caused record flooding on the North Branch Hoosic River in August 2011 and led to severe bank erosion that damaged Route 8 just 0.2 mi upstream of the former dam site (Figure 1; Web citation 3). In addition, a large mass failure occurred relatively recently at the sharp bend in the river downstream of the dam and is assumed to have occurred during Tropical Storm Irene (Figure 6). Glacial clay present along the stream bottom suggests the river may have been temporarily dammed by the landslide. The flooding also largely infilled with coarse sediment the excavated channel upstream of the removed dam, forming a large mid-channel gravel bar that has diverted the majority of flow towards the right bank with a secondary side

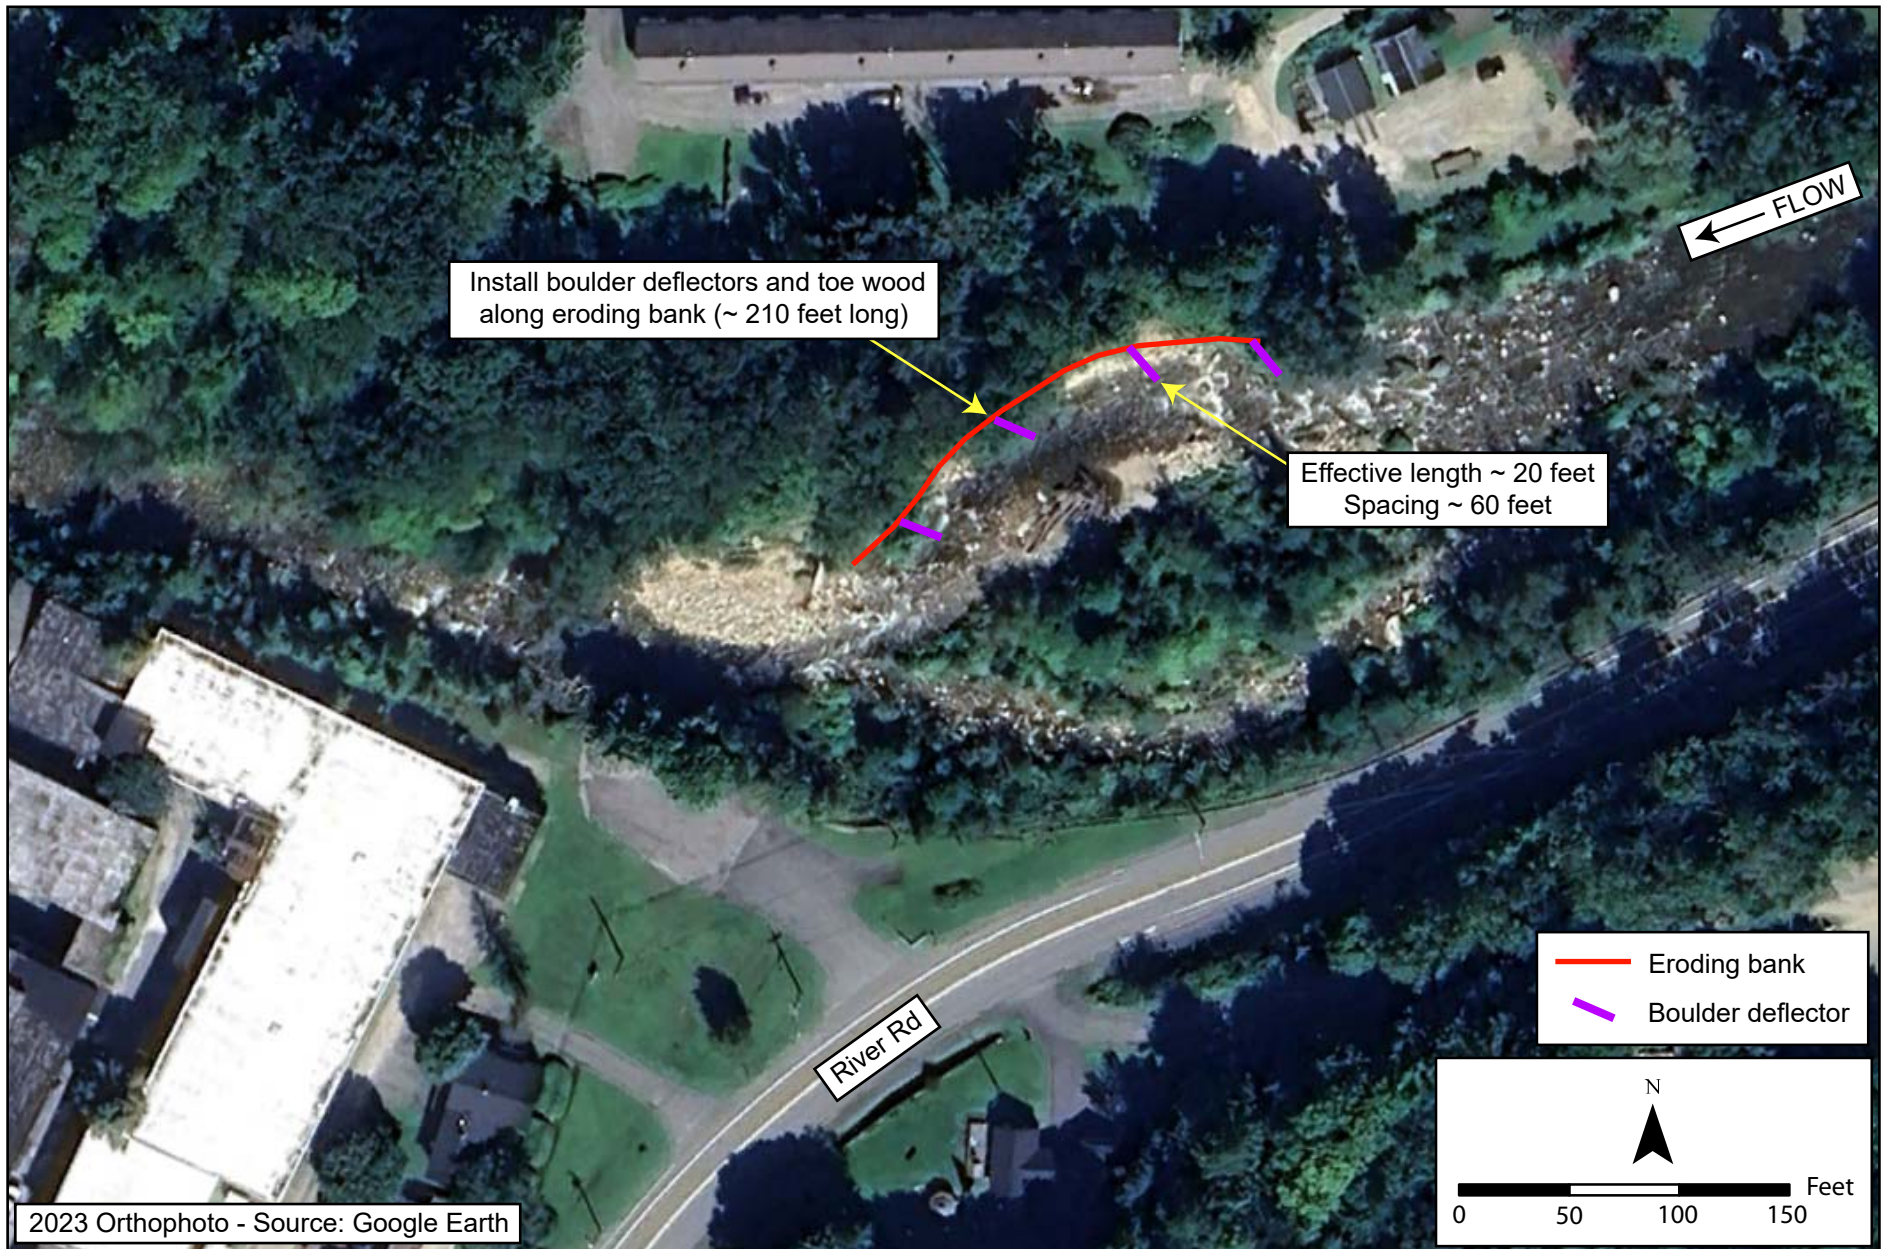
Conceptual design plan view - Boulder deflectors and toe wood.

Three bank stabilization options for the eroding right bank (Figure 2) are considered here: 1) construction of boulder deflectors along the eroding bank; 2) construction of boulder weirs across the channel; and 3) removal of the earthen berm and artificial fill. The pros and cons of each option are considered based on an analysis of six factors related to each stabilization technique: 1) appropriateness for the site; 2) durability and effectiveness; 3) consistency with natural processes; 4) temporary construction impacts; 5) habitat enhancement; and 6) potential impacts elsewhere (i.e., across channel and downstream) (Table 1). The chosen option will need to undergo a more thorough design phase to estimate costs, determine permitting requirements, and support grant applications for implementation funds. Owners of the condominium units and other stakeholders should be engaged throughout the decision-making process to gauge their response to the temporary and long-term impacts of each stabilization option.

Deflectors at the Briggsville site are likely to induce sediment deposition effectively at the toe of the eroding bank given the considerable amount of sediment deposited around logs and other obstructions in the area (Figure 11). However, boulder deflectors are prone to damage from undermining of the footer boulders by bed scour or lateral outflanking around the back end of the structures where they tie into the bank (Table 1). Both problems are valid concerns at the Briggsville site. The steep channel bed upstream of the former dam is currently maintained by large boulders armoring the channel bed (Figure 10) but if that armor layer is mobilized, then bed scour will occur rapidly as the bed slope adjusts to the lower river level resulting from the dam removal. While the footer boulders can protect against minor bed scour created by the structure itself, footer boulders cannot protect against the significant bed lowering related to the dam removal.

Lateral outflanking of deflectors is also a significant risk at the Briggsville site given that the eroding bank along which the deflectors will be built is composed of uncompacted artificial fill (Figure 8). Scour is most severe where softer materials are in contact with harder materials such as boulders. While this problem could be mitigated by baffling the flow's energy with logs and brush anchored over the contact between the boulders and loose fill, the excavation into the uncompacted fill that will be required along much of the bank to both anchor these protective logs and to set the footer boulders of the deflectors could cause significant collapse of the loose fill and compromise the integrity of the structures from the outset.

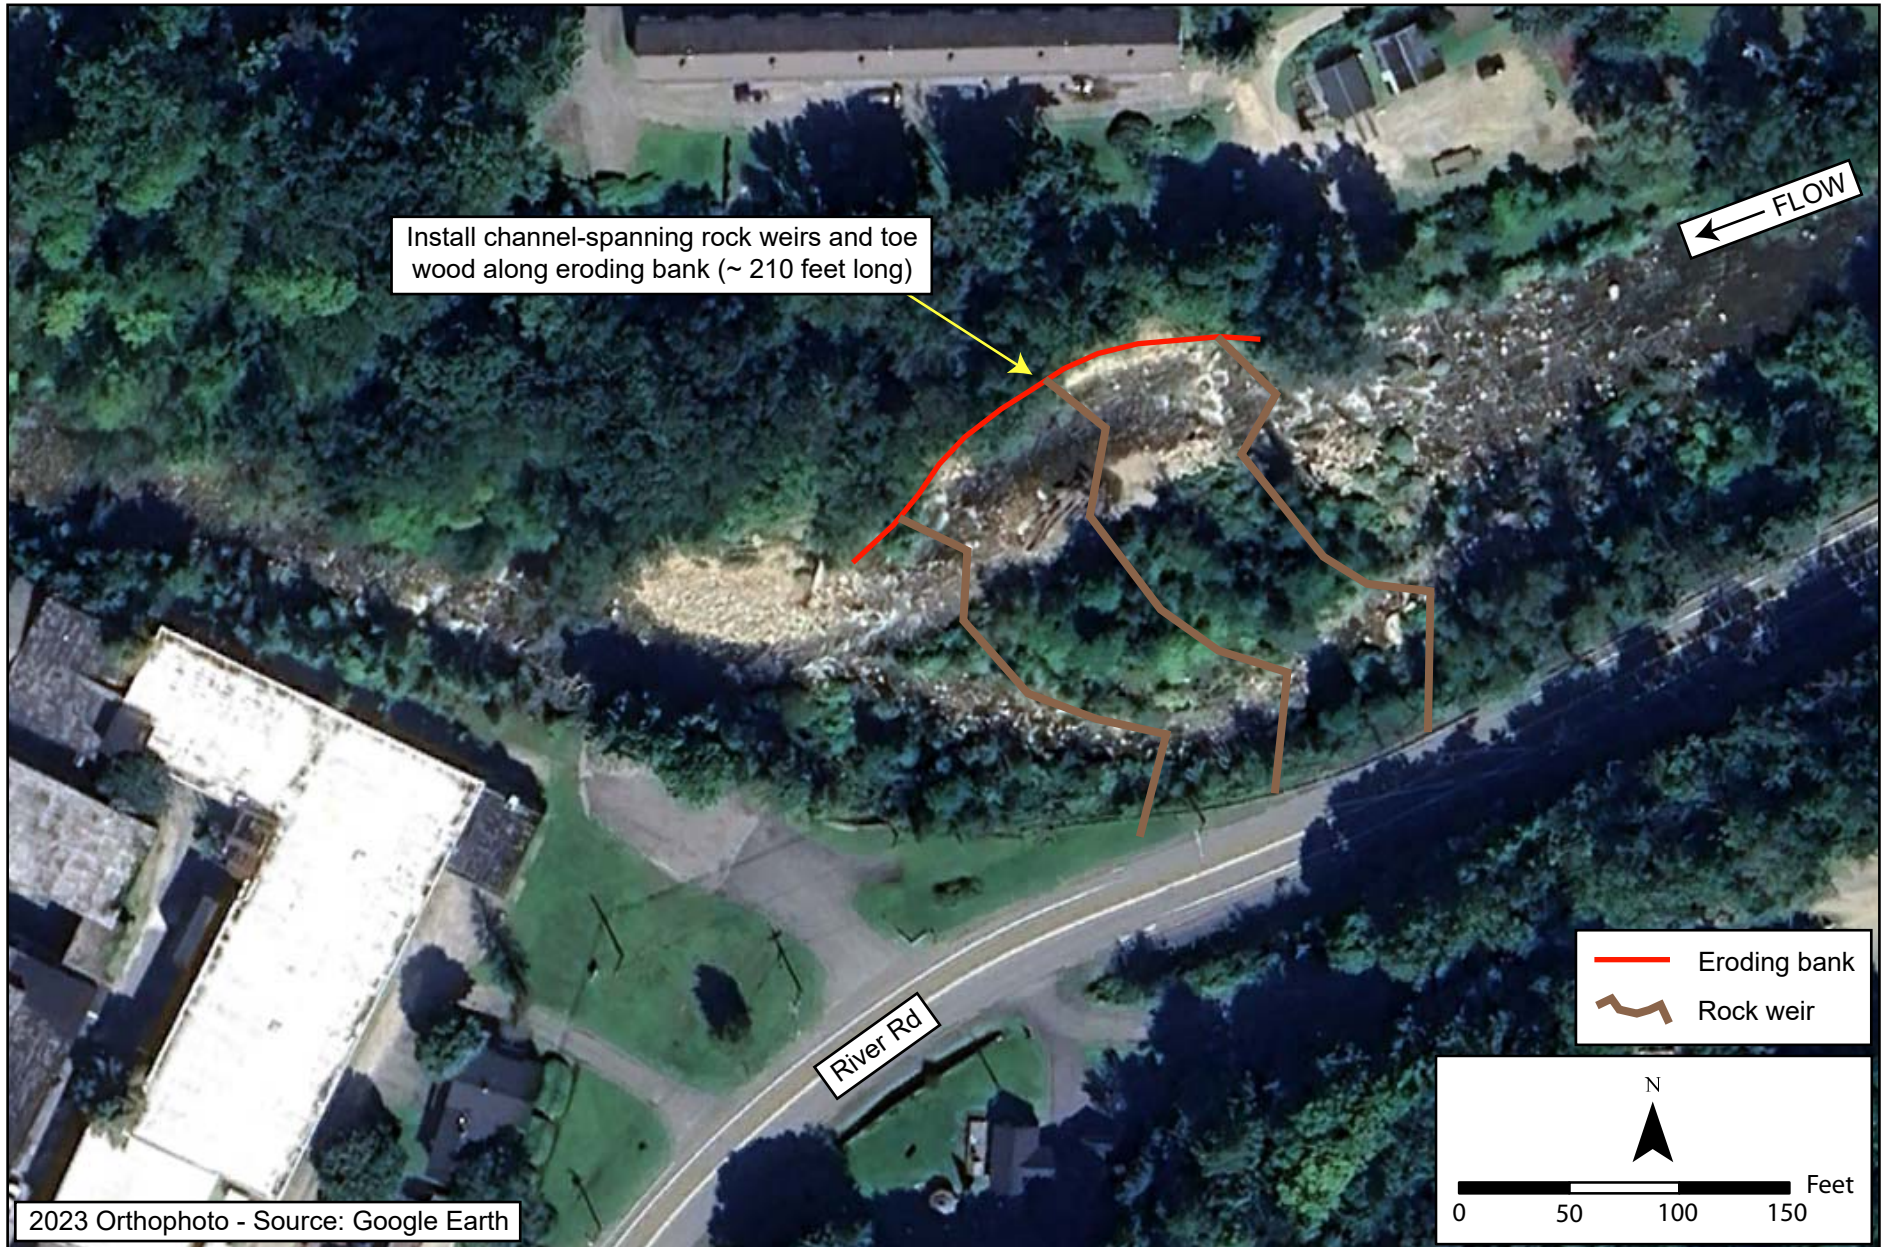
Conceptual design plan view - Rock weirs and toe wood.

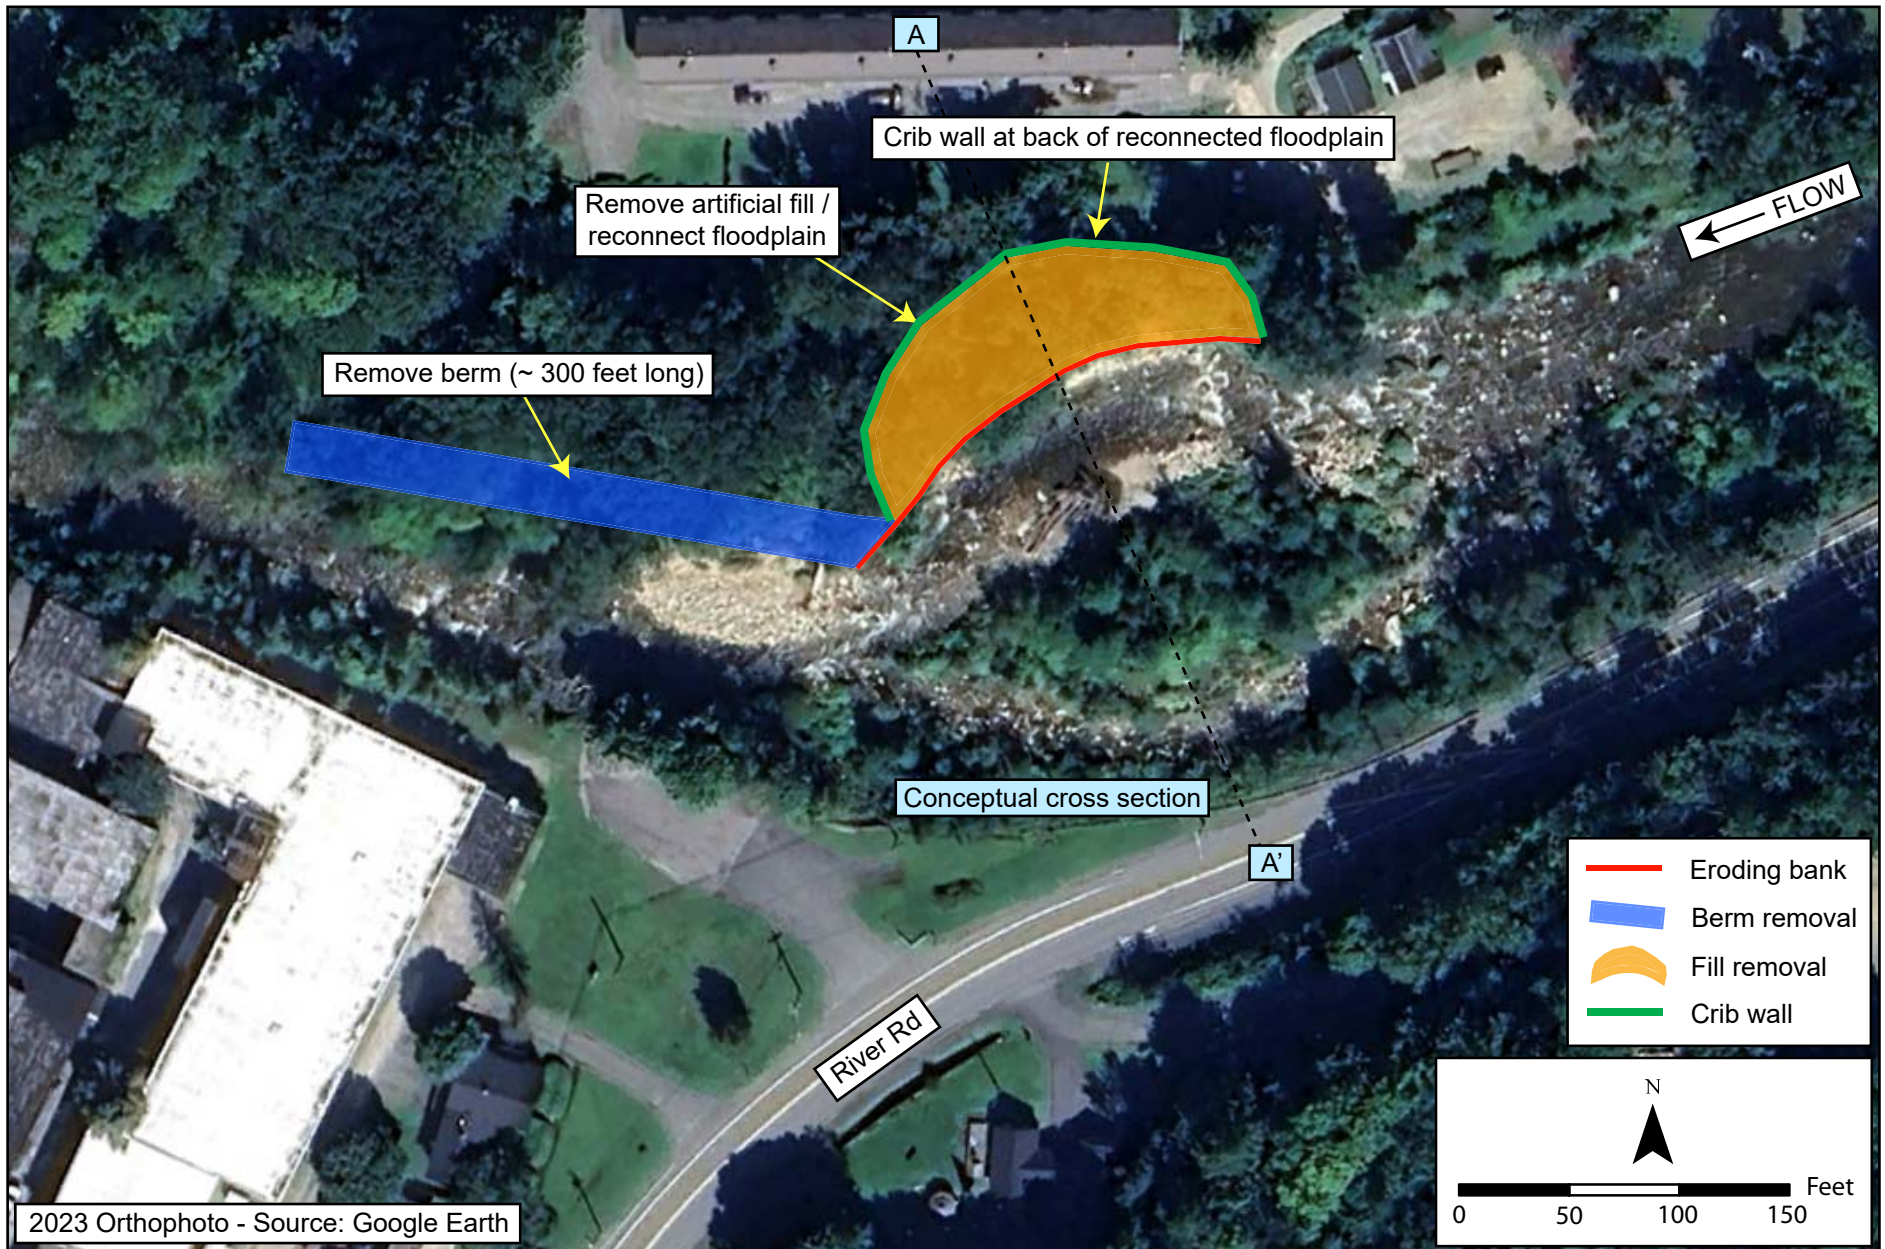
Conceptual design plan view - Remove berm and artificial fill.

The eroding right bank upstream of the former dam, as described above, is composed of artificial fill (Figure 8). Investing considerable funds to stabilize the eroding bank may not be advisable given that the uncompacted nature of the fill increases the risk of outflanking. Restoring the natural floodplain that existed prior to dam construction through removal of the earthen berm (Figure 4), artificial fill (Figures 2, 7, and 8), and remnant of old dam (Figure 9) provides a more sustainable approach for reducing erosive forces in the immediate area as well as further downstream (Appendix 1). The berm and fill are currently artificially constraining floods such that they impart a greater erosive force on the channel margins and more quickly convey flows downstream, potentially increasing the risk of large mass failures as has occurred in the past (Figures 1 and 6). By removing these constraining features, floodplain flow could be restored on the right bank, reducing erosive forces on the left bank along Route 8 and further downstream where considerable infrastructure and high unstable banks are present. Restoring the floodplain would also be beneficial to aquatic organisms by reducing flow velocities in the channel and providing side-channel habitat on the restored floodplain.

Removal of the artificial fill would address the bank erosion by greatly reducing the height of the bank; the current bank height did not exist prior to dam construction and placement of the fill. The final height of the floodplain and remaining bank will have to be determined in a later project design phase, but erosive forces on the remaining low bank will be greatly reduced by allowing flows to access the restored floodplain. While erosion of the low bank is still possible, allowing the river to migrate across the floodplain would provide greater resiliency during large flood events and minimize erosive forces and flood peaks downstream (Table 1). Given the presence of the condominiums on the higher surface (Figure 2), the back side of the lowered floodplain surface would need to be stabilized to ensure significant channel migration does not initiate erosion of the higher surface. The use of a log crib wall filled with large rock could be used for stabilization to provide both habitat and a greater peace of mind to residents potentially concerned about the risk of erosion closer to the condominiums (Appendix 1). However, erosion along the backside of the floodplain is unlikely to ever be a severe threat for at least three reasons. First, the slope rising to the level of the condominiums is composed of native less erosive materials compared to the currently eroding bank of artificial fill (Figure 2). Second, the erosive forces of flow on the floodplain will not be as strong as those currently present in the confined channel. Finally, removal of the earthen berm downstream (Figure 4) will reduce or eliminate the backwatering of flood flows that led to the deposition of the mid-channel bar and subsequent flow diversion into the now eroding right bank (Figure 7). If the berm is removed, sediment will more readily pass through the area, the size of the mid-channel bar will be reduced over time, and redirection of flow towards the right bank will be less likely.

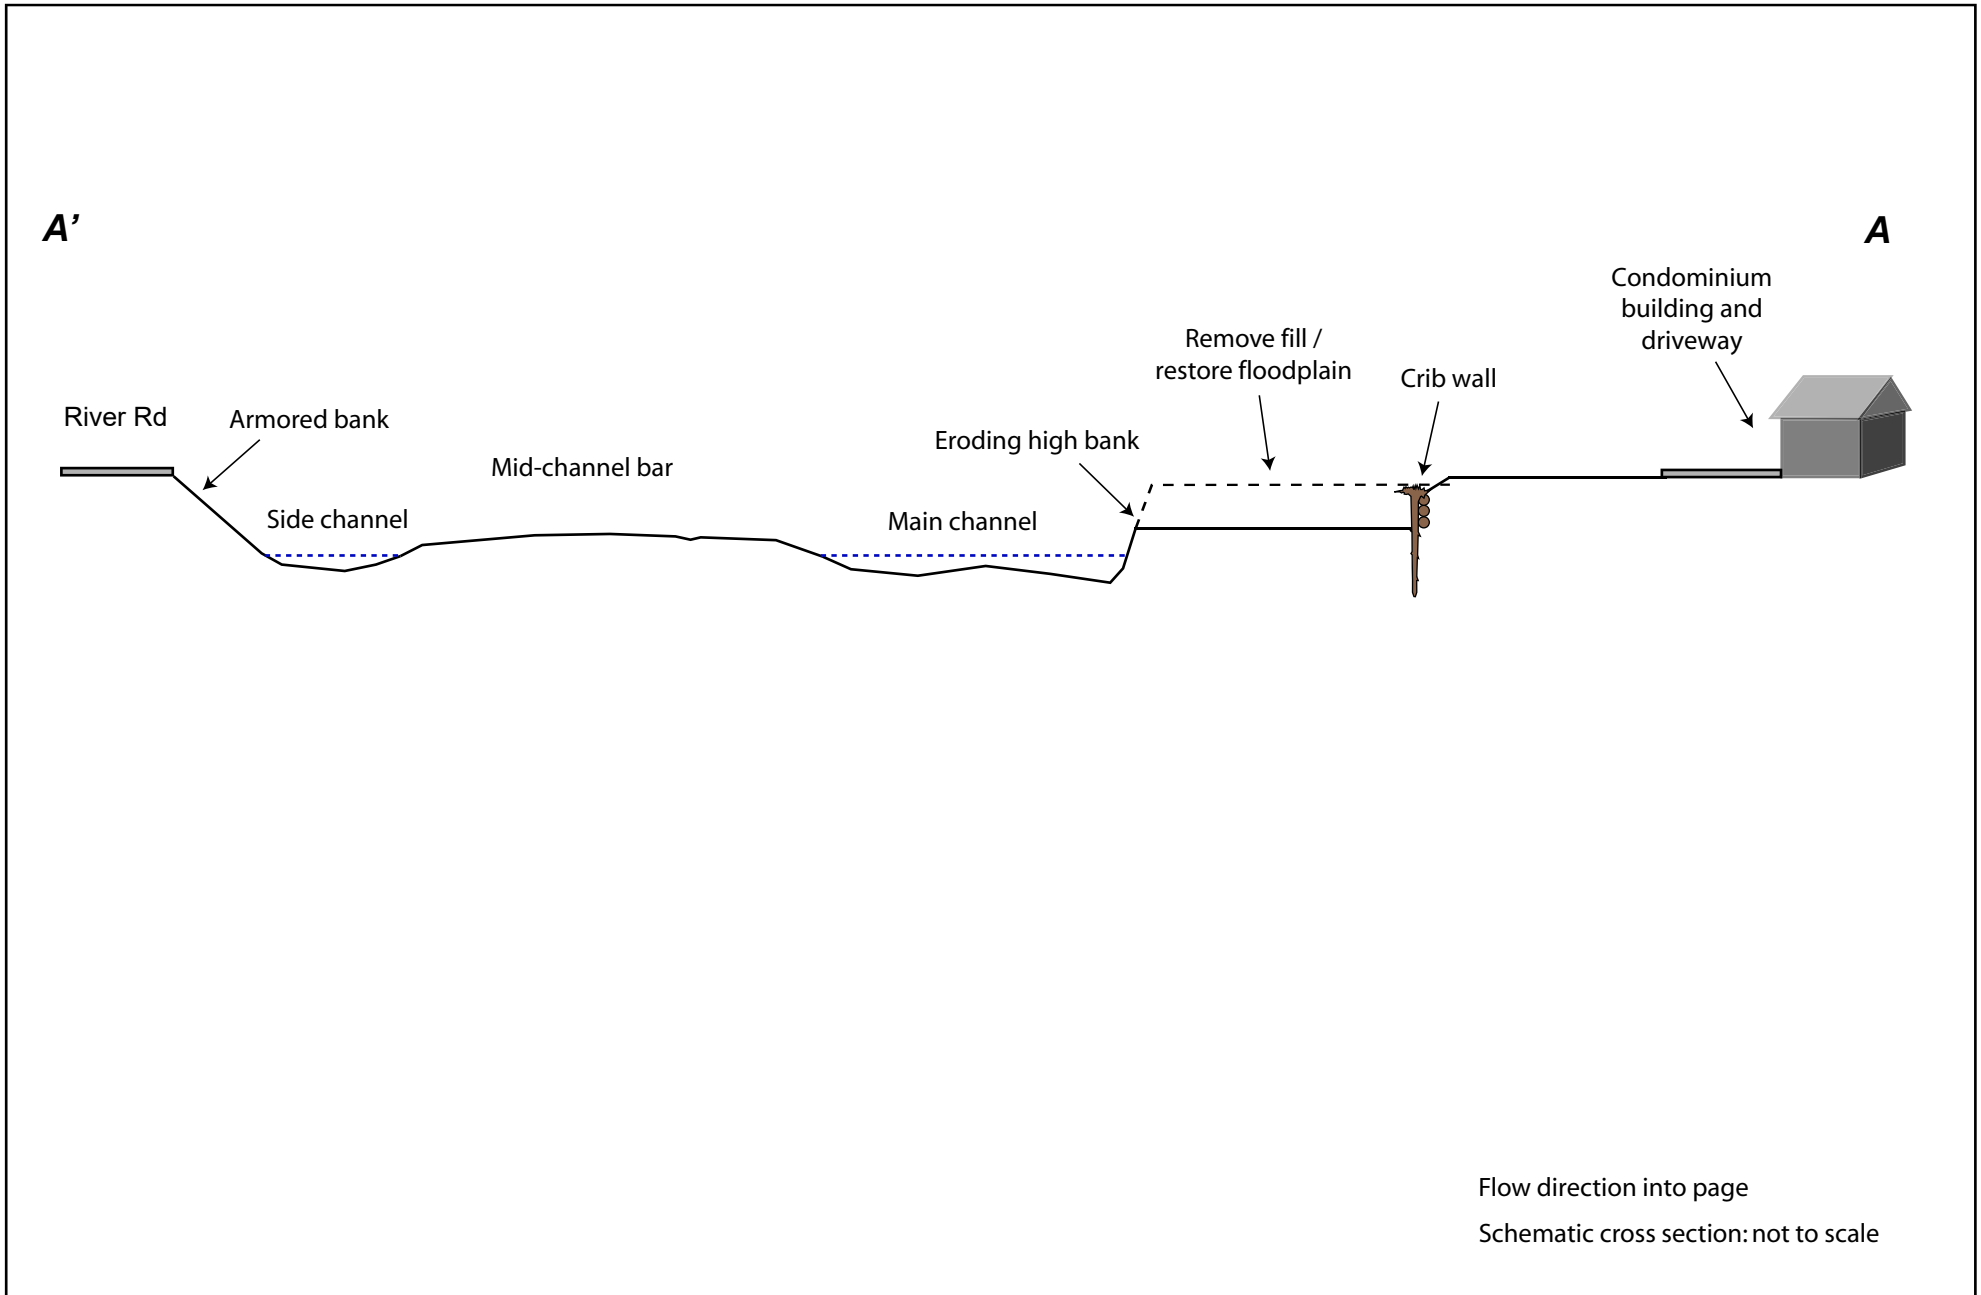
Conceptual design cross section - Remove berm and artificial fill.
