Town of Clarksburg Hazard Mitigation and Climate Adaptation Plan

Adopted November 11, 2021

Selectboard, Town of Clarksburg, Massachusetts
A RESOLUTION ADOPTING THE TOWN OF CLARKSBURG
2021 HAZARD MITIGATION AND CLIMATE ADAPTATION PLAN

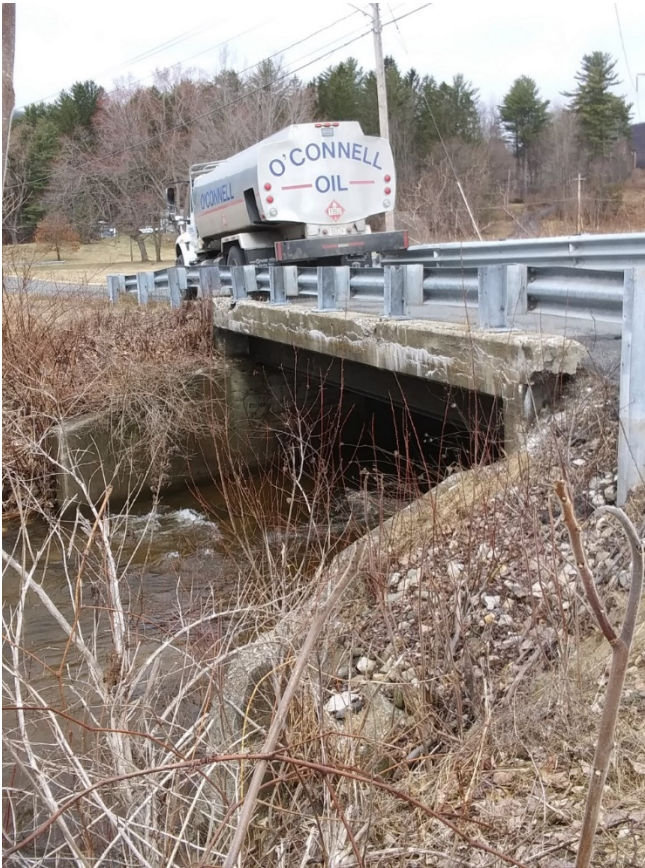
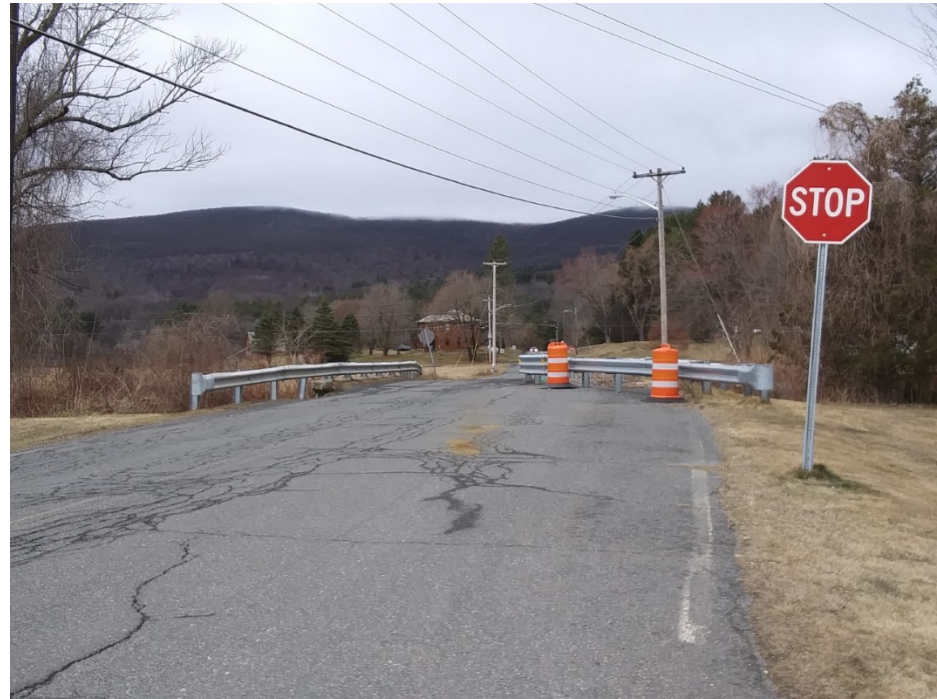
Figs. 3.6-3.7. Cross Road Bridge has deteriorated to the point that it is down to a one-lane road.

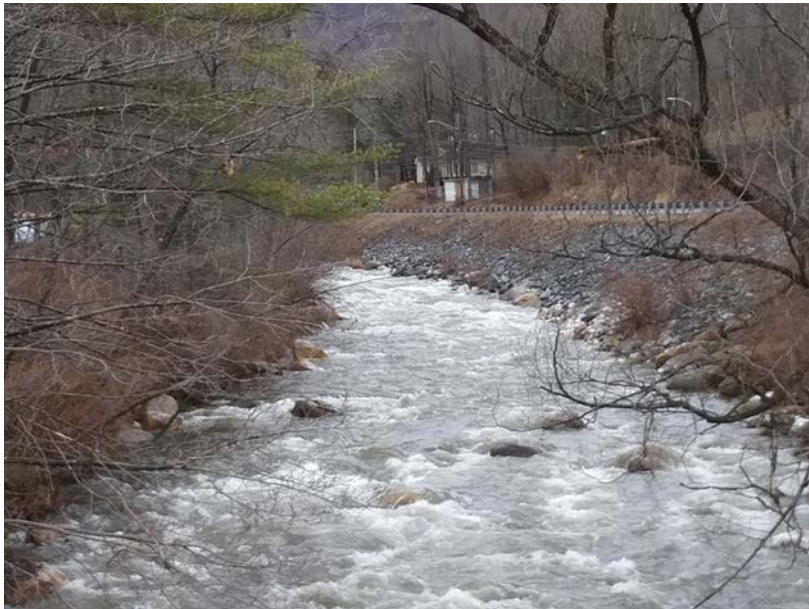
North Branch Hoosic River Lateral Movement

The North Branch Hoosic River is a dynamic river prone to extremely high flows and volumes of water during spring snow melt season and times of extreme precipitation events. The river channel is fairly narrow with high banks on both sides. River Road (Rt. 8) runs along the eastern/southern side of the river here and development is located along the western/northern side of the river. Homes and businesses are located along Carson Avenue and its junction with Cross Road at the Mary Baker Bridge. Powerful floodwaters erode the banks of the river and for decades has periodically damaged River Road, requiring frequent re-armoring of the riverbank and repairs to the roadway. According to historic newspaper reports, several repair projects involving adding fill and asphalt to the sinking road surface and armoring the bank with rip rap have been conducted along the river in the years preceding 1976, 1978-79, 1987, and 2011.

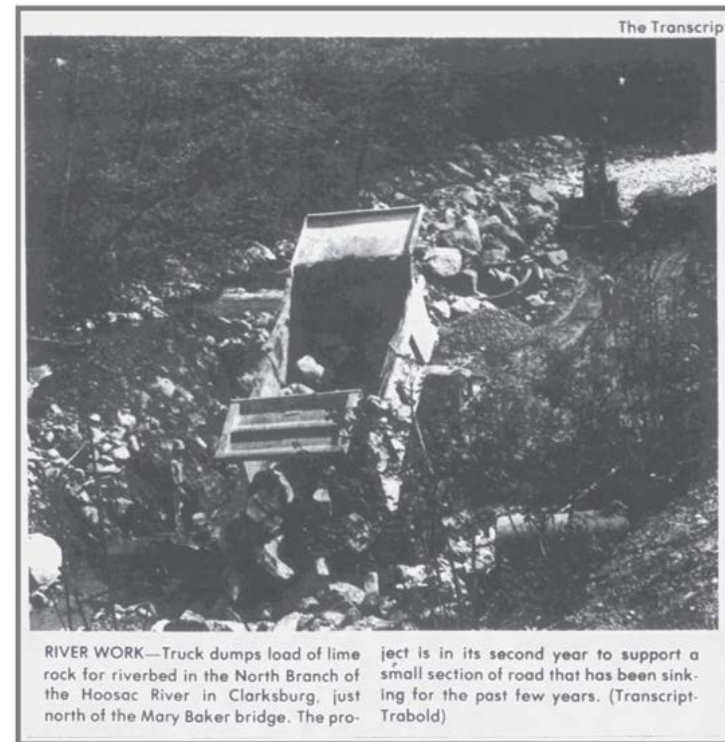
RIVER WORK—Truck dumps load of lime rock for riverbed in the North Branch of the Hoosac River in Clarksburg, just north of the Mary Baker bridge. The project is in its second year to support a small section of road that has been sinking for the past few years. (Transcript-Trabold)

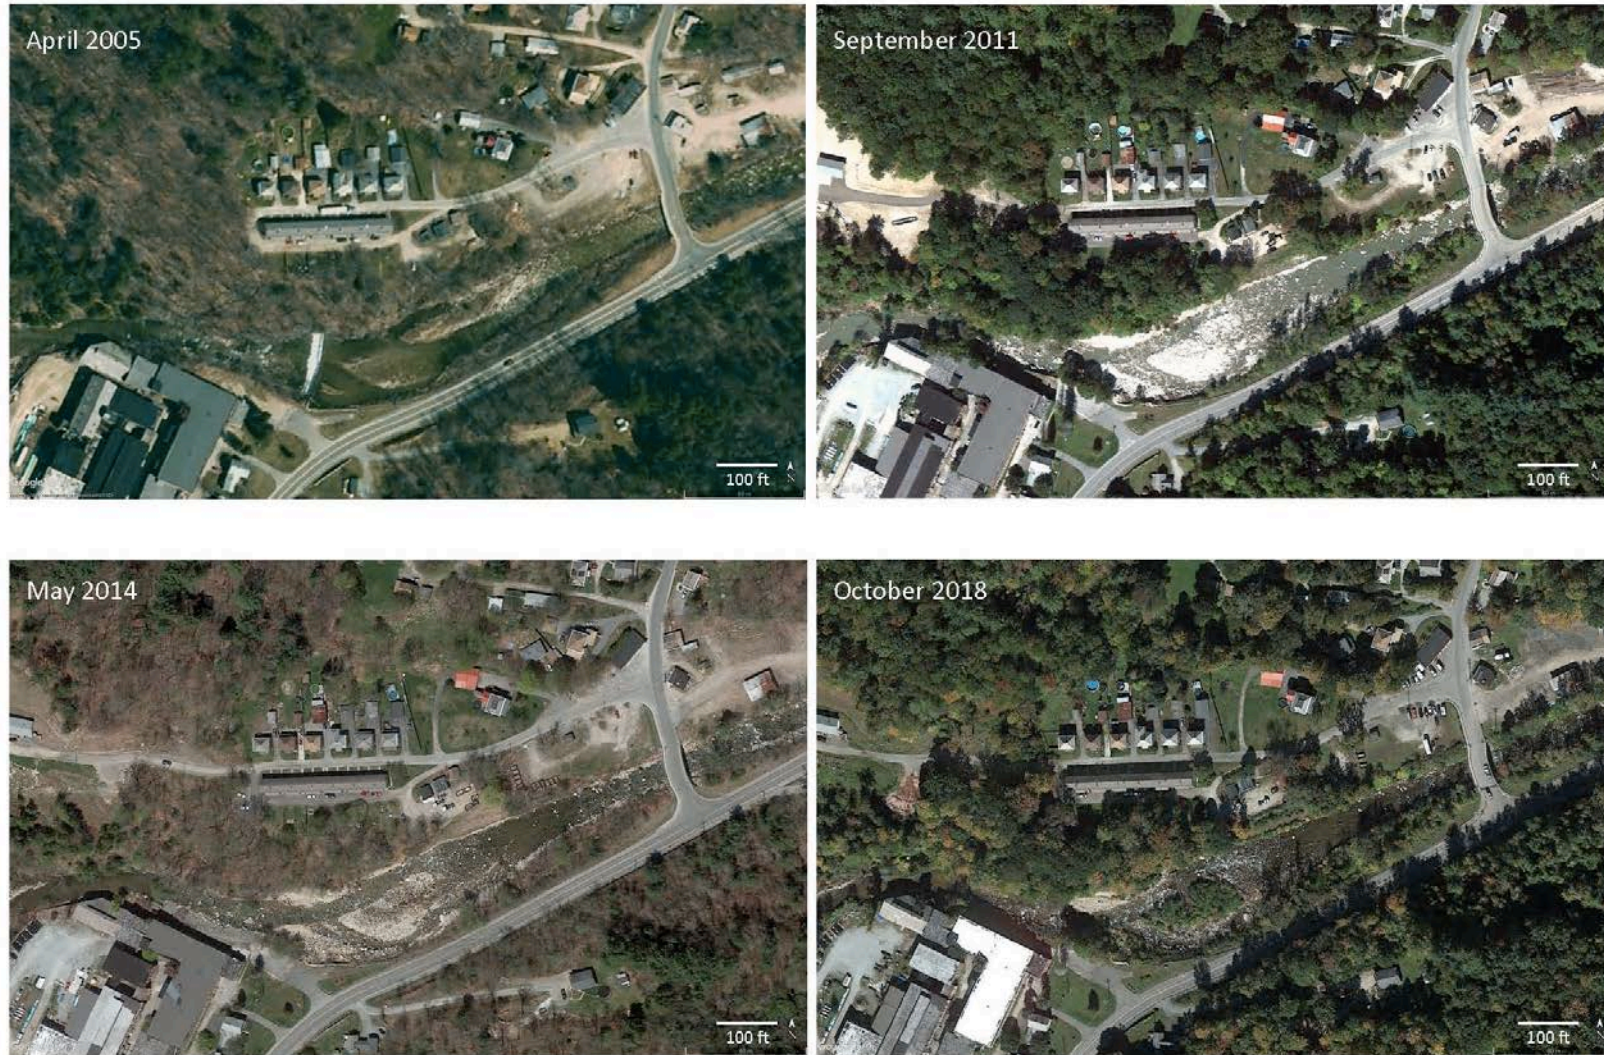
Fig. 3.10. Changes in the channel of the North Branch Hoosic River 2005-2018

Development of a vegetated, longitudinal, teardrop-shaped medial bar over time within the Hoosic River (north branch) near Carson Avenue, following removal of the Briggsville dam in Dec 2010. Tropical storm Irene struck during late August 2011.

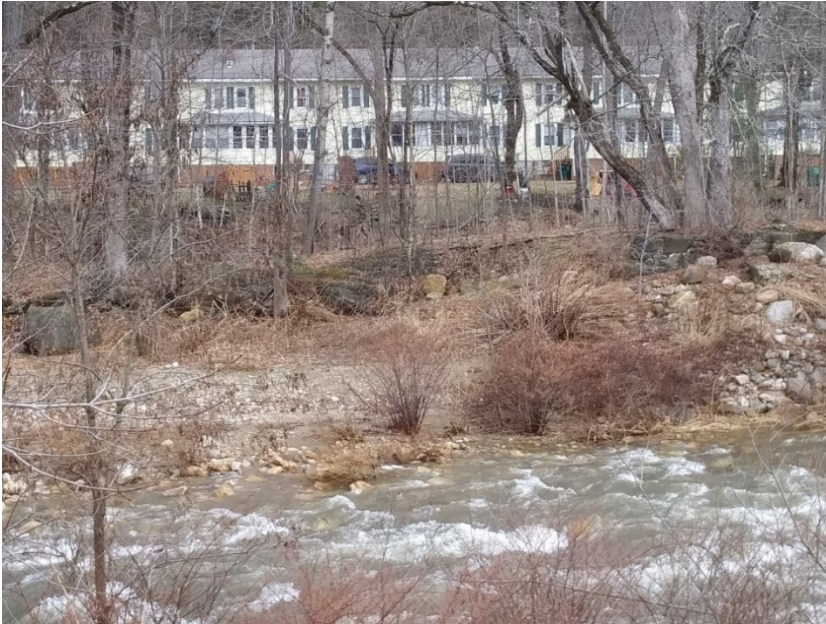
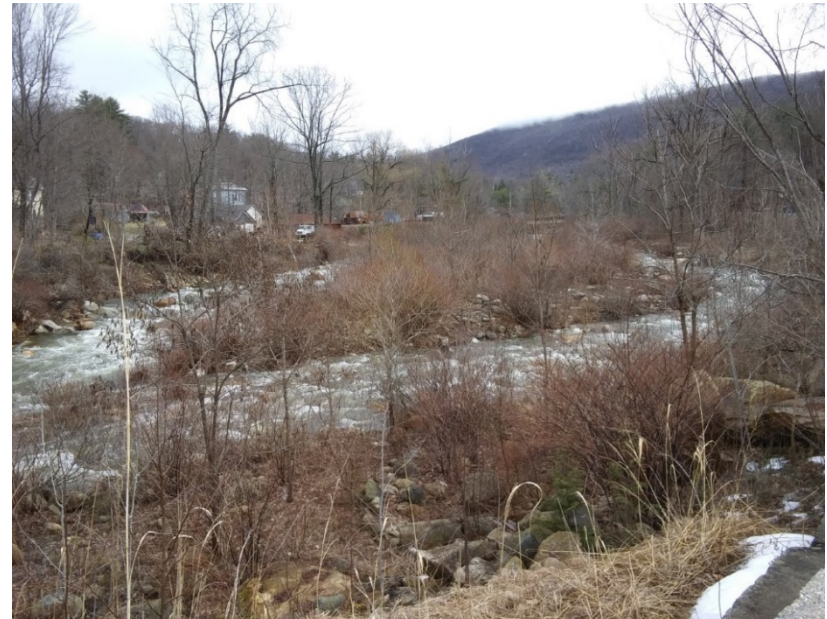
Figs. 3.12 – 3.13. 2021. North Branch Hoosic River below right: the medial bar downstream from the Mary Baker bridge causes flood waters to erode the western/northern river bank. **Below left:** the erosion of the west/north riverbank with Carson Avenue homes in the background.

- Erosion of the bank on N. Branch Hoosic River
- Just above and below the Mary Baker bridge

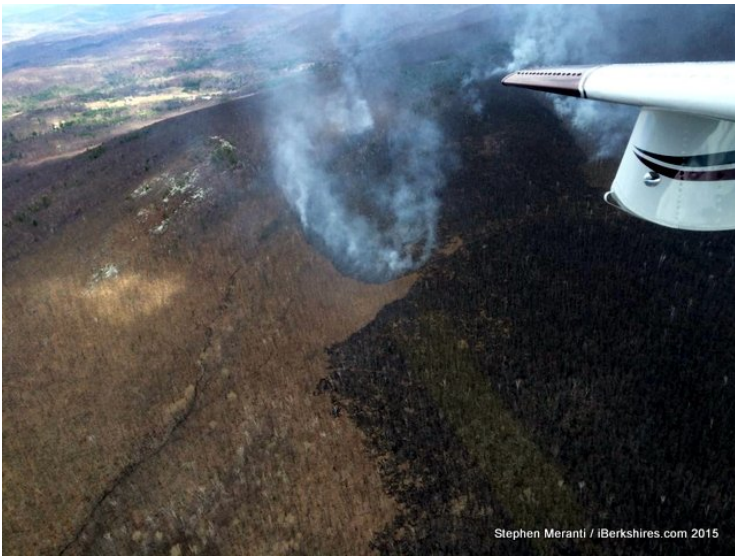
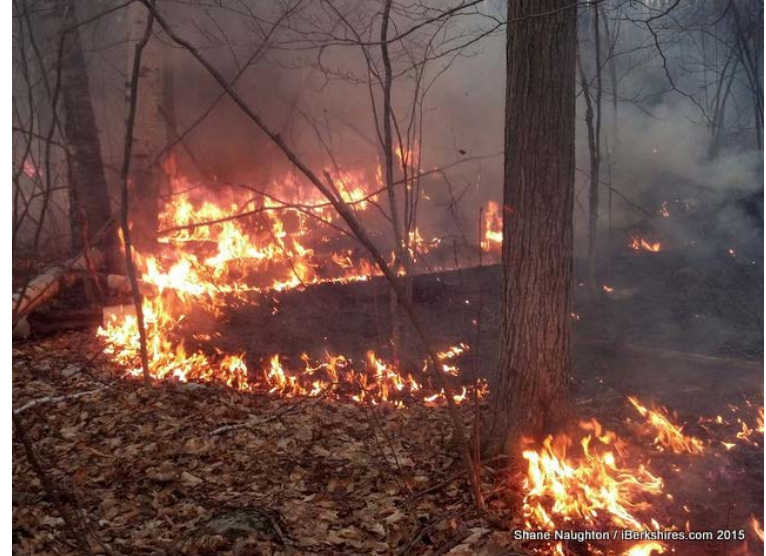
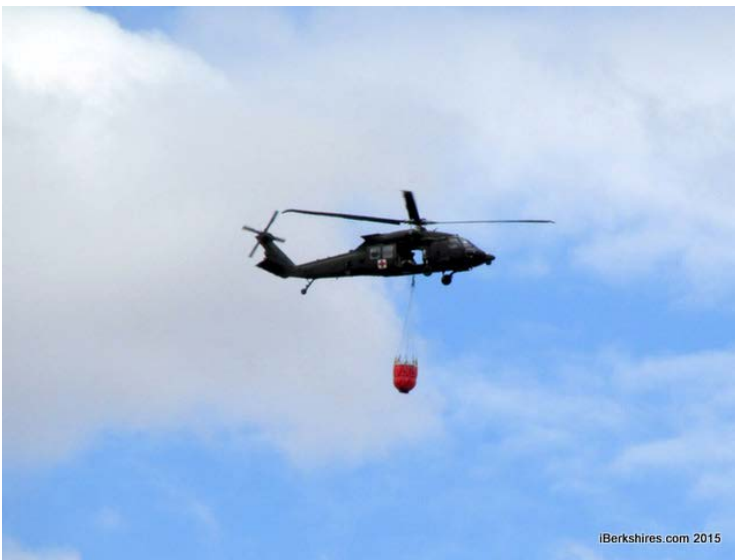
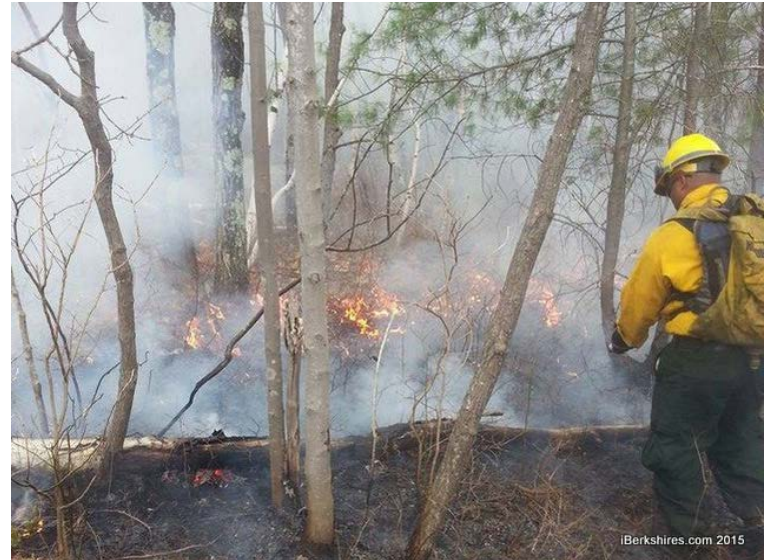
Figs. 3.25-3.28. The 2015 Clarksburg fire burned outward from its origins along Sherman Brook camp site. The area was very inaccessible and much of the firefighting was done on foot using portable water packs. A helicopter bringing water from Mt. Williams Reservoir in North Adams made the difference in fighting the fire. *Photos taken from "Clarksburg Brush Fire Contained on Third Day," iBerkshires, 5-1-15.*

Hawk helicopter drop water on the fire, ferrying 500 gallons of water at a time from Mount Williams Reservoir in North Adams.²¹ Photos of the fire and response are shown in Figures 3.25-3.28.

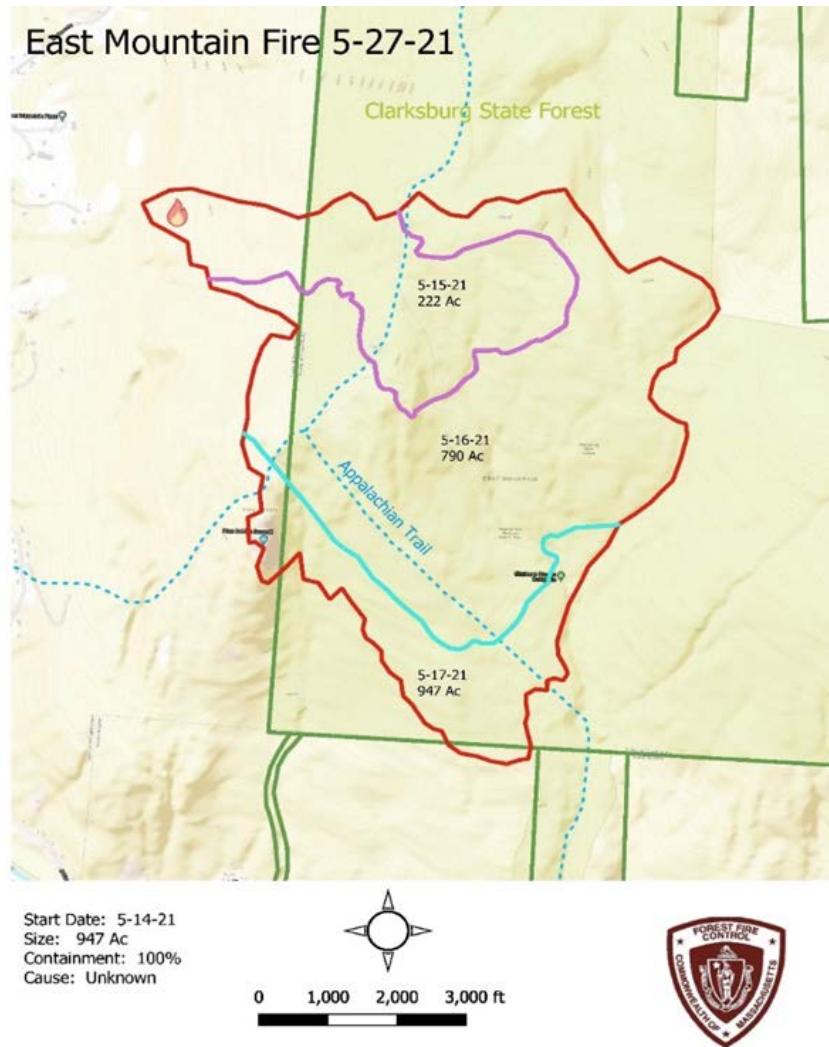
Fig. 3.29. Progression of the 2021 East Mountain Fire

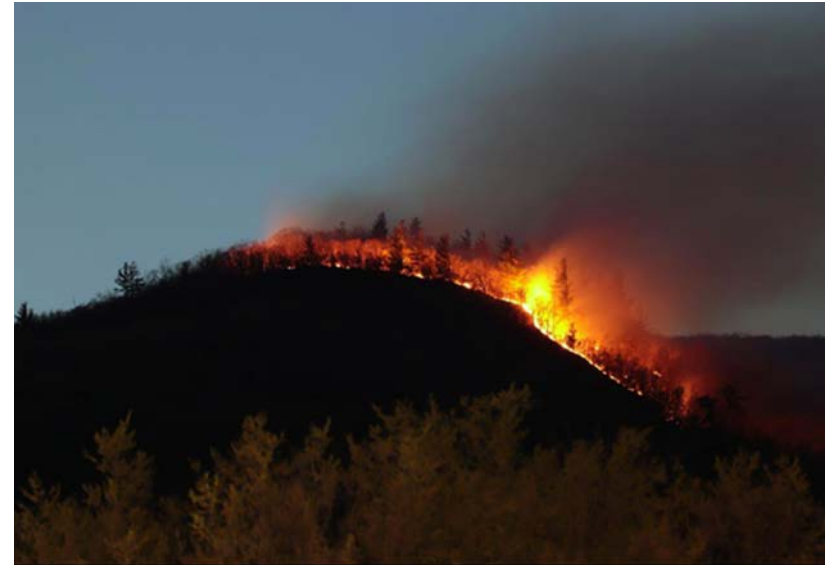
Fig. 3.30. Fire on East Mountain, Clarksburg, MA. Photo taken May 16, 2021 from Stop & Shop parking lot on Route 2 in North Adams.

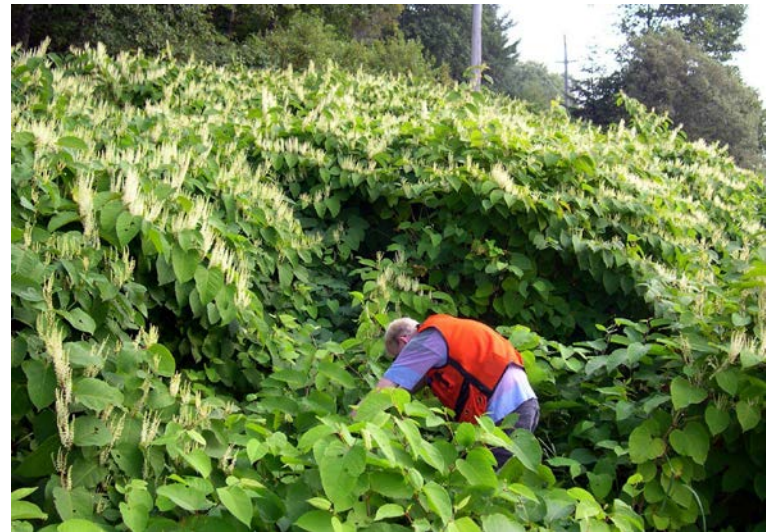
Fig. 3.31. Example of Japanese knotweed infestation in bloom

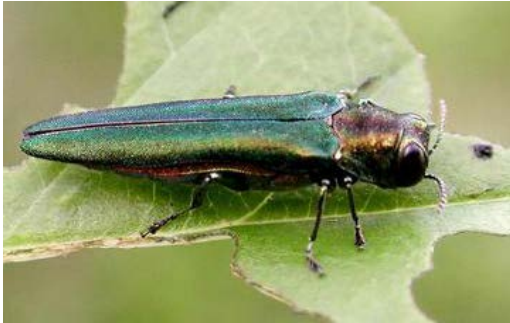
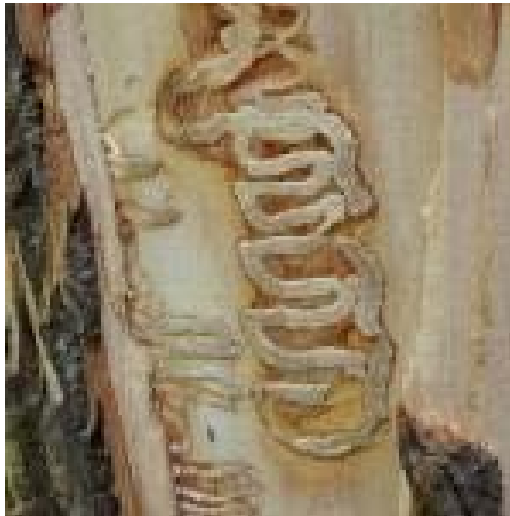
trees' cambium, eventually girdling and killing the tree. Damaged trees can be spotted by the bleached appearance of the bark, where larvae have damaged the tissue beneath. Many town officials in Berkshire County have reported having to take down dead and dying ash trees along public roadways for public safety.

Fig. 3.32. Left: Emerald Ash Borer Adult; damages caused by larvae under tree bark

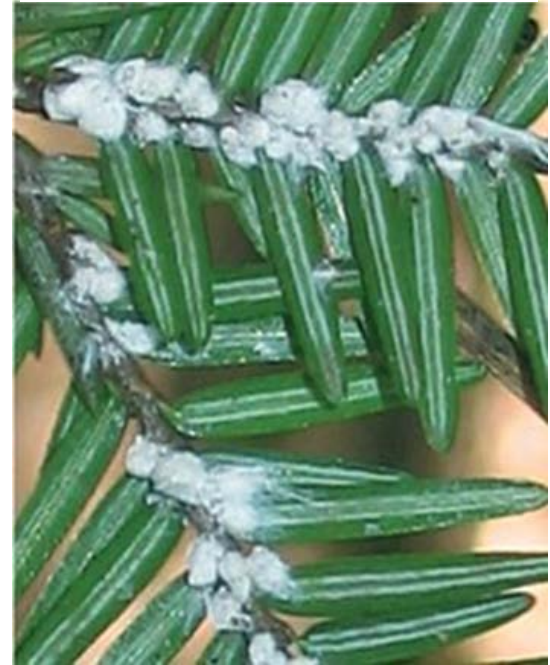
Warmer winter temperatures are raising the survival rates of some insect pests and allowing them to expand their range. The Hemlock Woolly Adelgid is an insect that kills Eastern Hemlocks. This insect has been expanding northward, having crossed into the Housatonic River Valley from Connecticut in the early 2000s. In the Berkshires, hemlocks are valuable because they survive along steep ravines and help to hold soil in place. Streams within hemlock forests have a greater diversity of aquatic invertebrates to support fish as compared to those within hardwood forests. Native brook trout are three times more likely to be found in streams surrounded by hemlock, which provide cooler water temperatures and more stable flows.

Fig. 3.33. Below: Hemlock Woolly Adelgid Infestation

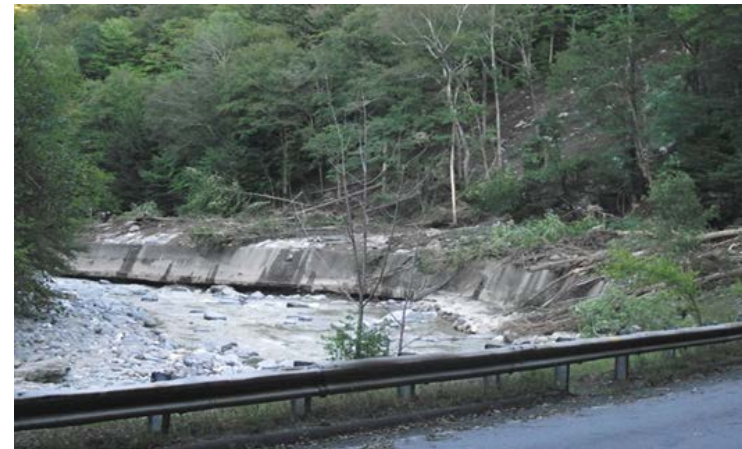
Figs. 3.43., 3.44. Landslide in Savoy, MA August 2011

Local news articles indicates that landslides of exposed bedrock occur periodically along the steep slopes of the Mohawk Trail in the vicinity of the Hairpin Turn. These areas are show in red in the Slope Stability Map and are located mostly in Florida. The Eagle Restaurant, which is located in Clarksburg, is located on land rated Unstable by the computer model. The most severe landslide to occur in the Berkshire region occurred along the Mohawk Trail (Route 2) in along the Florida/Savoy boundary during T.S. Irene in 2011 (Figures 3.43, 3.44). The landslide was 900 feet long, approximately 1.5 acres, with an average slope angle is 28° to 33° . The elevation difference from the top of the slide to the bottom was 460 feet, with an estimated volume of material moved being 5,000 cubic yards. Only the top 2 to 4 feet of soil material was displaced (BRPC, 2012). The soil and tree debris covered the entire width of Route 2 and caused its closure for weeks (see bottom photo left). The landslide had a significant impact on northern Berkshire County communities because Route 2 is a major east-west transportation route in that region.

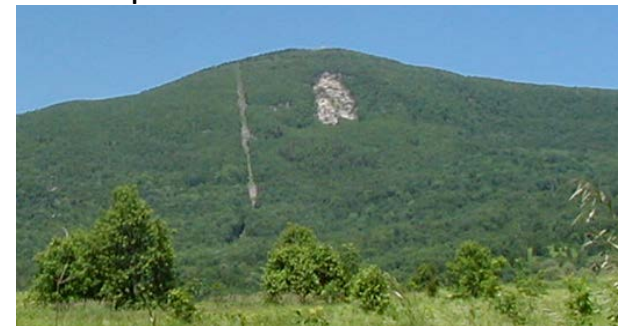
Fig. 3.45. Mount Greylock in Adams, MA. The 1990 landslide area was still void of vegetation in 1999 when this photo was taken.

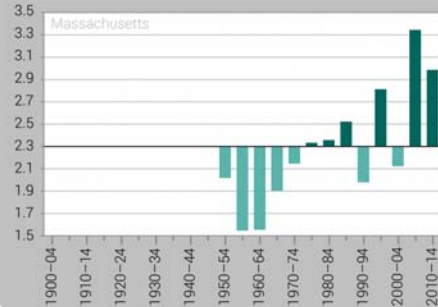
Number of Events w/ Precipitation > 2" in 1 day

- 55% increase 1958-2016 in heavy rain/snow ranked top 1% of daily events
- 55% increase in extreme precipitation includes 9-year drought
- ~30% increase in precipitation events >2" in 1 day (see right)
- >2"/day often = flooding, especially if rain on snow/frozen ground

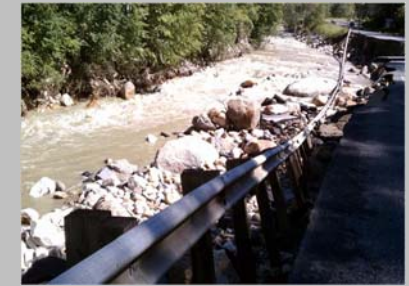
T.S. Irene 2011 in Clarksburg

- River Road collapses
- Several road damages & closures
- Flooding of property & basements
- Fire Dept. receives >50 calls
- Some evacuations
- Floodwaters approach Town Hall
- Conduit for travel for Vermonters
- T.S. Lee Sept. 2011

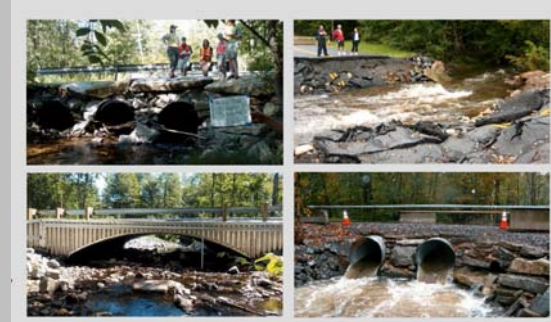
New full span bridge reduces risk of repeated failure

Clockwise from top left: First replacement crossing (2009); catastrophic culvert failure due to Tropical Storm Irene (2011); "emergency temporary replacement" crossing (2011); replacement bridge (2016).

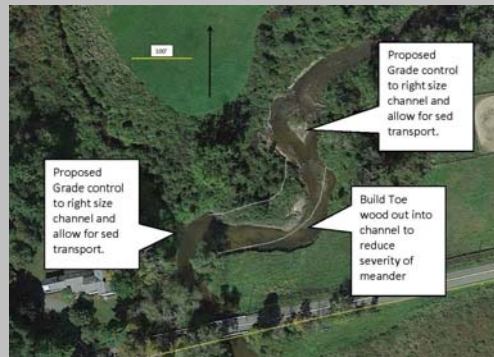
Mitigation Example: Bank Stabilization, New Marlborough:

To reduce flooding and possible loss of road
